# **INDOOR AIR QUALITY ASSESSMENT**

**Claypit Hill Elementary School  
40 Adams Lane  
Wayland, MA**

Prepared by:  
Massachusetts Department of Public Health  
Bureau of Environmental Health  
Indoor Air Quality Program  
March 2019

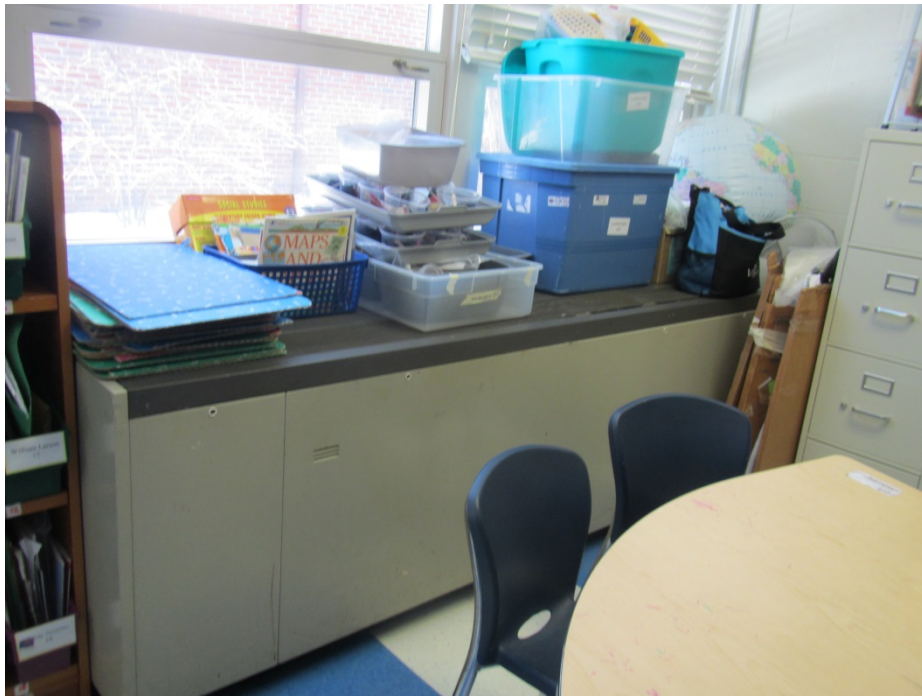
**Picture 1**

Fresh air in most classrooms is supplied by unit ventilators (univents)( Picture 1). Univents draw air from the outdoors through a fresh air intake located on the exterior wall of the building (Picture 2) and return air through an air intake located at the base of the unit. Fresh and return air are mixed, filtered, heated or cooled and provided to rooms through an air diffuser located in the top of the unit ([Figure 1](#)).

**Unit ventilator (univent), note items on top and in front**

1. Operate the HVAC system to provide for *continuous* fresh air ventilation during occupied hours.
2. Remove furniture and items blocking the front and top of univents. Remove furniture and items from in front of exhaust vents.

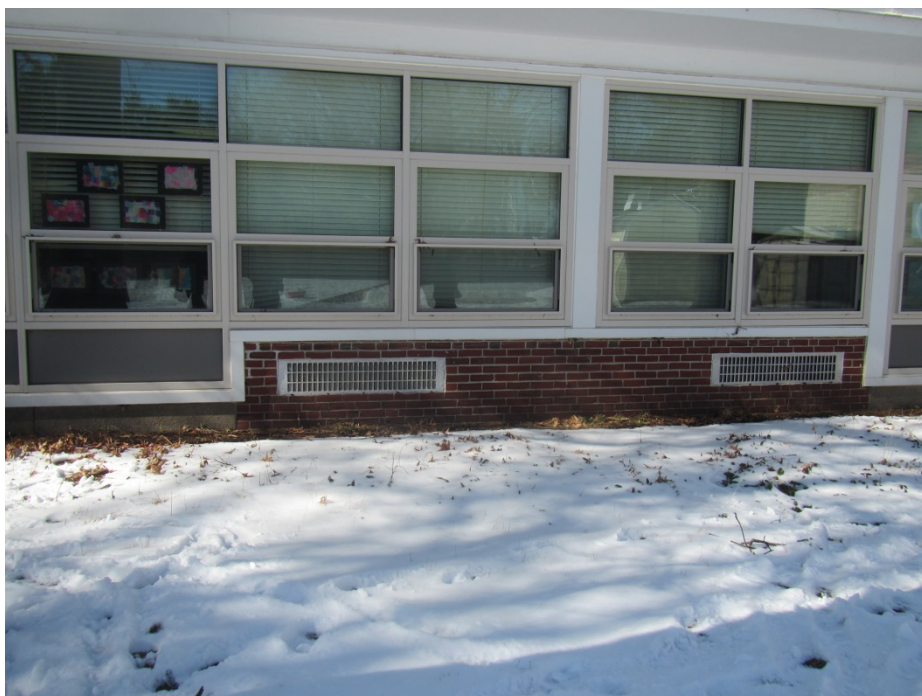
**Picture 2**

**Univent fresh air intakes**

27. Clean supply and exhaust vents and fans regularly to remove accumulated dust/debris.
28. Ensure that screens are installed on univent fresh air intake vents to prevent pest entry or debris accumulation.

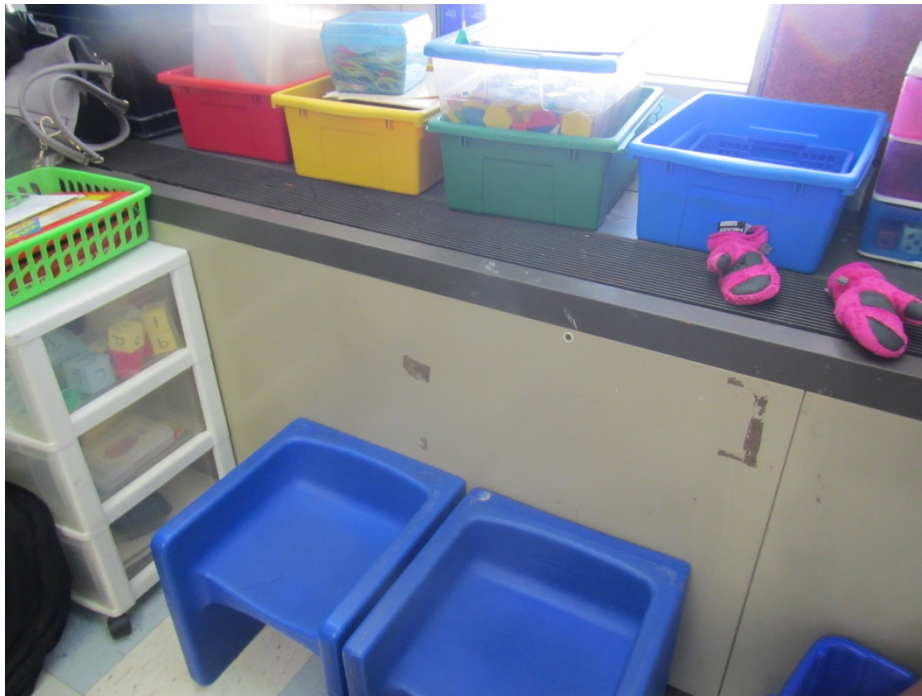
**Picture 3**

In many rooms the top and/or front of univents were blocked by classroom items and furniture (Picture 3). In order for univents to provide fresh air as designed, intakes/returns must remain free of obstructions. Importantly, these units must remain on and be allowed to operate while rooms are occupied. It is also important to note that outside air is typically limited (by adjusting intake louvers) during cold/winter months to provide comfort and prevent the freezing of pipes.

**Univent obstructed with items/furniture**

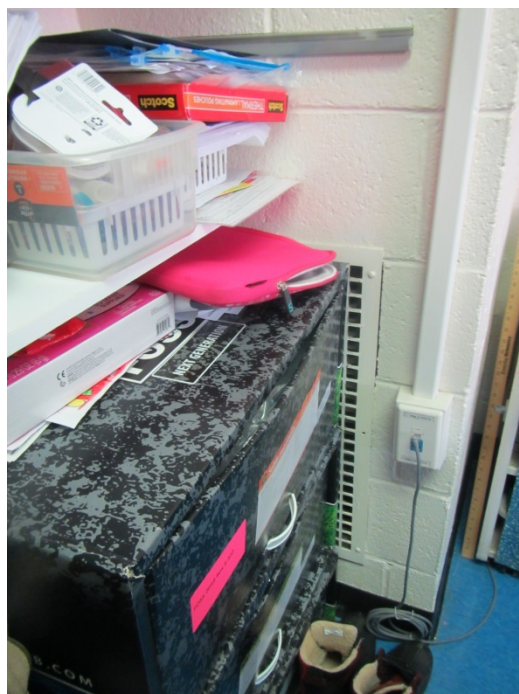
**Picture 4**

In some areas, exhaust vents did not appear to be drawing air (Table 1). This may be due to deactivation by the settings on the HVAC system, broken motors or fan belts. Many exhaust vents in classrooms were obstructed by items and furniture (Picture 4; Table 1). These obstructions should be removed for proper airflow. Also note that in many classrooms, the exhaust vents are located near the classroom doors. When the doors are open, the exhaust vents may draw air from the hallway rather than the classroom. For best operation of the ventilation system, hallway doors should be closed. Lack of exhaust ventilation, particularly in areas where

**Significantly obstructed exhaust vent**

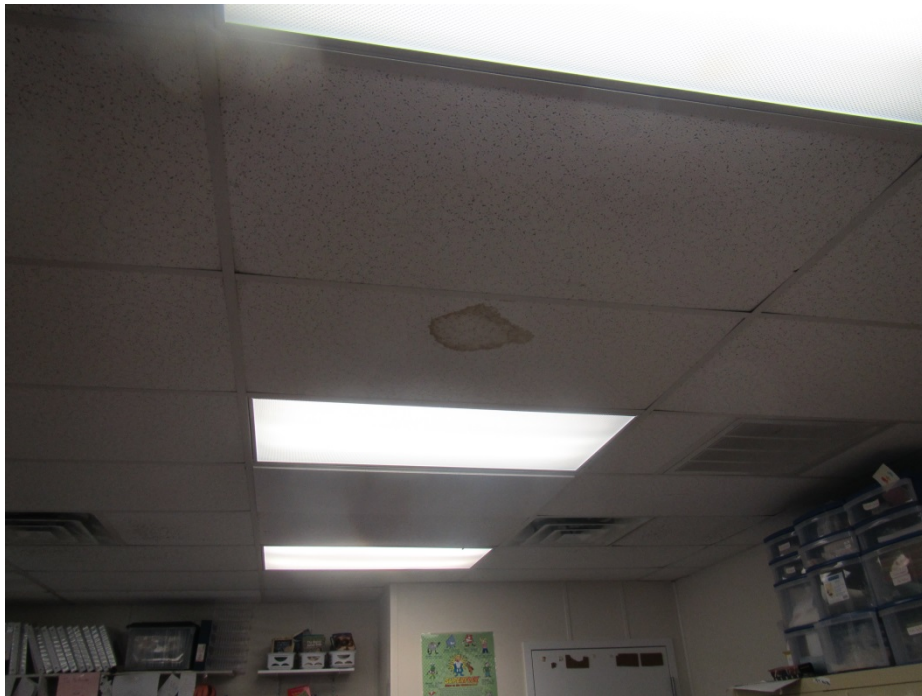
**Picture 5**

Water-damaged ceiling tiles were observed in a few areas (Picture 5; Table 1) which were attributed to roof leaks. Portions of the roof were repaired recently, meaning some of these damaged tiles are from historic leaks. Water-damaged ceiling tiles can provide a source of mold and should be replaced after a water leak is discovered and repaired. The library had multiple stained ceiling tiles. Library occupants expressed concerns regarding continuing roof leaks that occur during rainstorms. The library is carpeted and contains books and other porous materials that can become moldy if exposed to chronic moistening. Occupants in the library reported that odors occur from carpeting during rainstorms. The US Environmental Protection Agency (US EPA) and the American Conference of Governmental Industrial Hygienists (ACGIH)

**Water-damaged ceiling tile**

10. Work with a roofing contractor/building engineer to investigate/repair building envelope leaks. Until this has been completed, avoid storing porous materials in areas of known leaks.

12. Replace water-damaged ceiling tiles and inspect above them to clean/disinfect any additional moistened material.
13. Repair sink backsplashes with appropriate sealant or replace. Avoid storing porous items or large amounts of items under sinks.

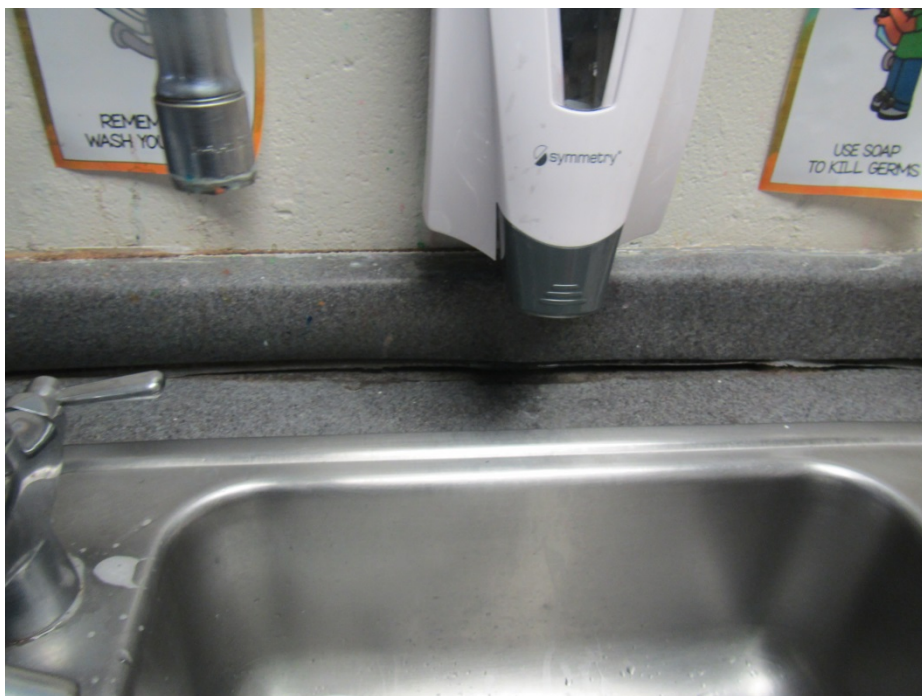
**Picture 6**

Some classrooms and storage areas have sinks. Some sinks have gaps in the backsplash which can lead to water damage and microbial growth in the material of the cabinet (Picture 6; Table 1). Backsplash gaps should be sealed or replaced with a one-piece unit. Some had large amounts of material stored underneath, including porous materials (Picture 7). The area under sinks can be a damp environment and should be kept clear of porous items which may become mold-colonized. Note that sinks and other drains that are not used regularly (e.g. little-used storage areas, locker rooms) can have the drain traps dry, which can allow sewer odors into the building. Drains should either be moistened periodically to maintain the trap seal, or be capped to prevent the infiltration of sewer odor/gases into occupied areas.

**Damaged sealant between bottom and side of backsplash**

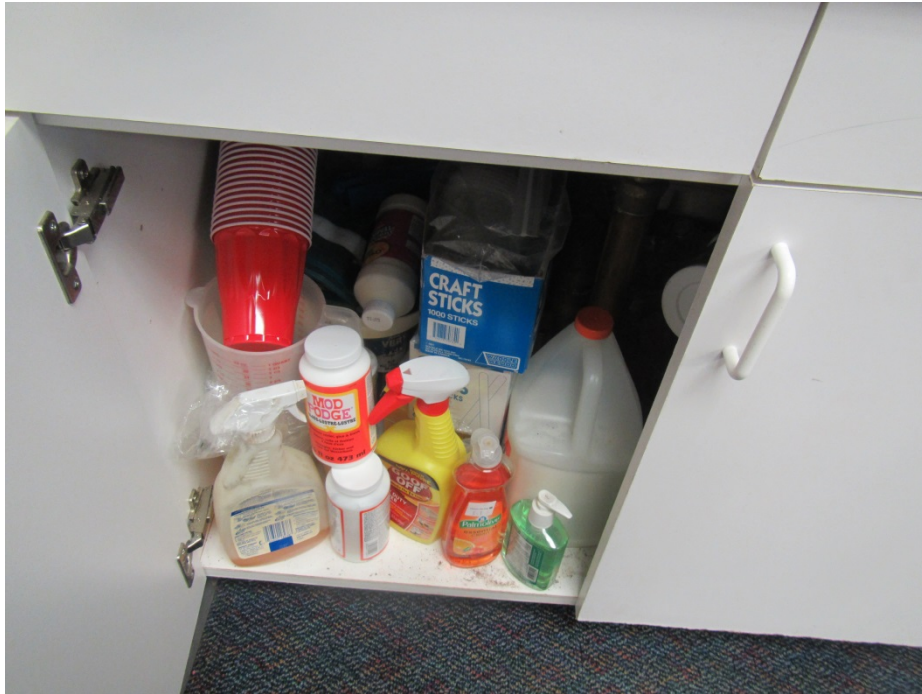
**Picture 7**

**Items, including porous items, under a classroom sink**

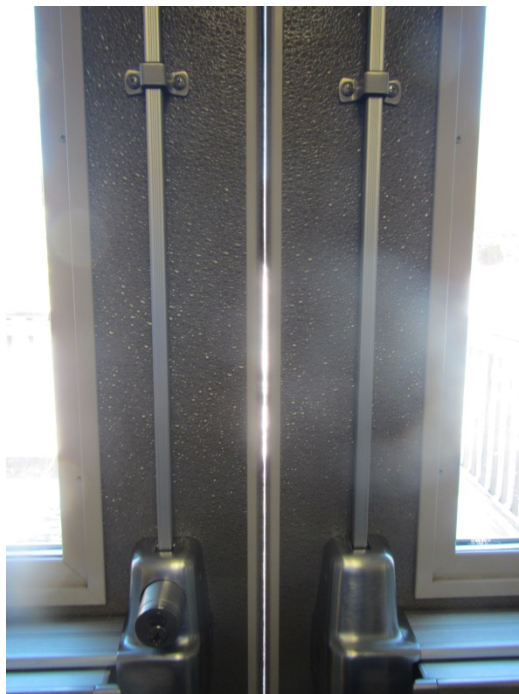
**Picture 8**

The exterior of the building was examined for conditions that may lead to water infiltration or other IAQ concerns. Exterior doors had light visible between the door and the frame (Picture 8) which indicates that weather-stripping needs to be added or replaced to prevent moisture and pests from entering the building. The book storage room was originally a maintenance/storage area with a garage-type roll-up door. This type of door is not weather-tight and may be a source of unconditioned air, moisture and pests (Picture 9).

**Exterior door missing weather-stripping**

19. Seal gaps between the crawlspace and occupied areas, including gaps around piping in univents.
20. Repair or replace weather-stripping on exterior doors for a tight fit that excludes unconditioned air and pests.

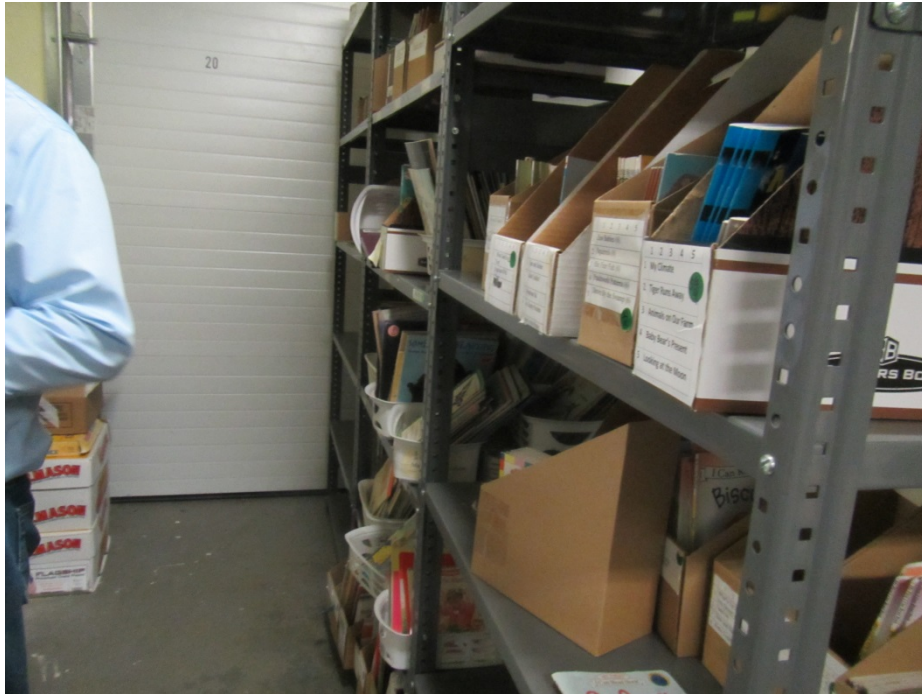
**Picture 9**

**Garage door in book room**

21. Seal the garage door in the book room with weather-stripping. Consider plans to replace this with a solid wall if it will continue to be occupied space.

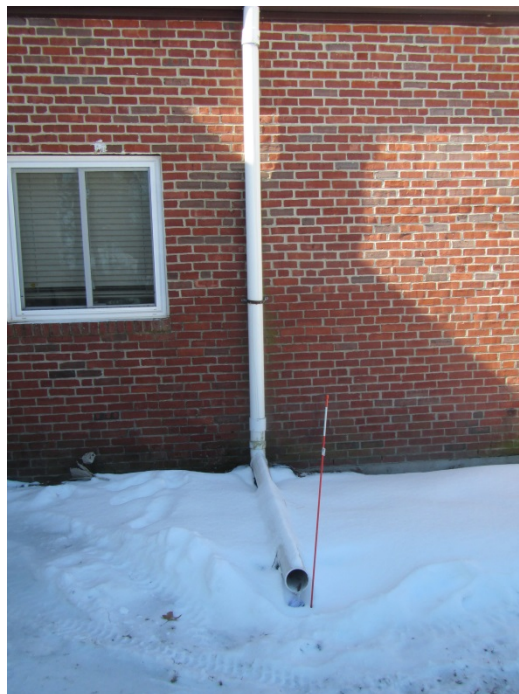
**Picture 10**

Some downspouts had been recently extended to direct water away from the base of the building (Picture 10), however a few terminated at the foundation (Picture 11). These should also be extended to drain water away from the building.

**Extended downspout**

22. Ensure downspouts direct water away from the building.
23. Trim back plants from the foundation approximately 5 feet, including in the courtyard.
24. Reduce or eliminate the use of air fresheners, scented cleaners, hand sanitizers and dry erase materials to reduce irritation. Consult the MDPH guidance “Clean Air is Odor-Free,” attached as [Appendix A](#), for more information.

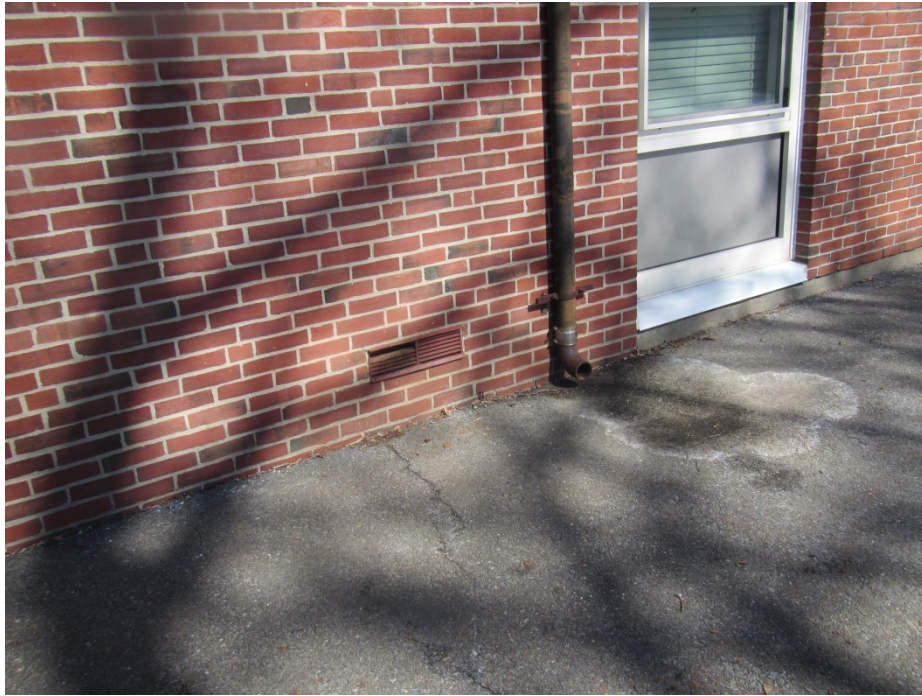
**Picture 11**

**Downspout terminating next to the foundation**

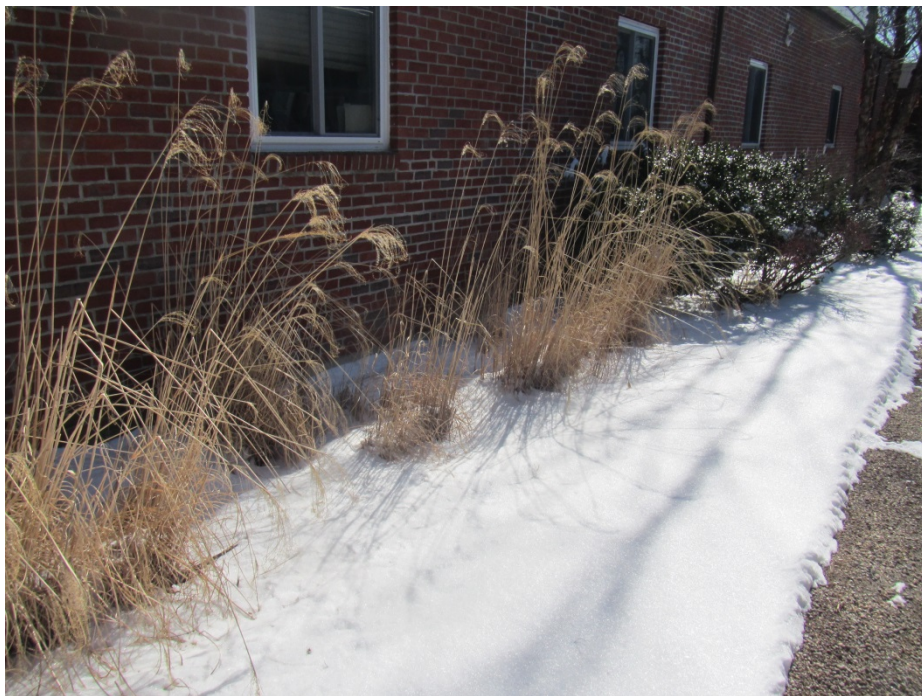
**Picture 12**

In a few areas, plants were observed near or against the exterior of the building (Picture 12). Plants can prevent the building from drying which may lead to damage, and plant roots may damage building foundations. Plants should be trimmed or removed to five feet away from the building.

**Plants next to the building**

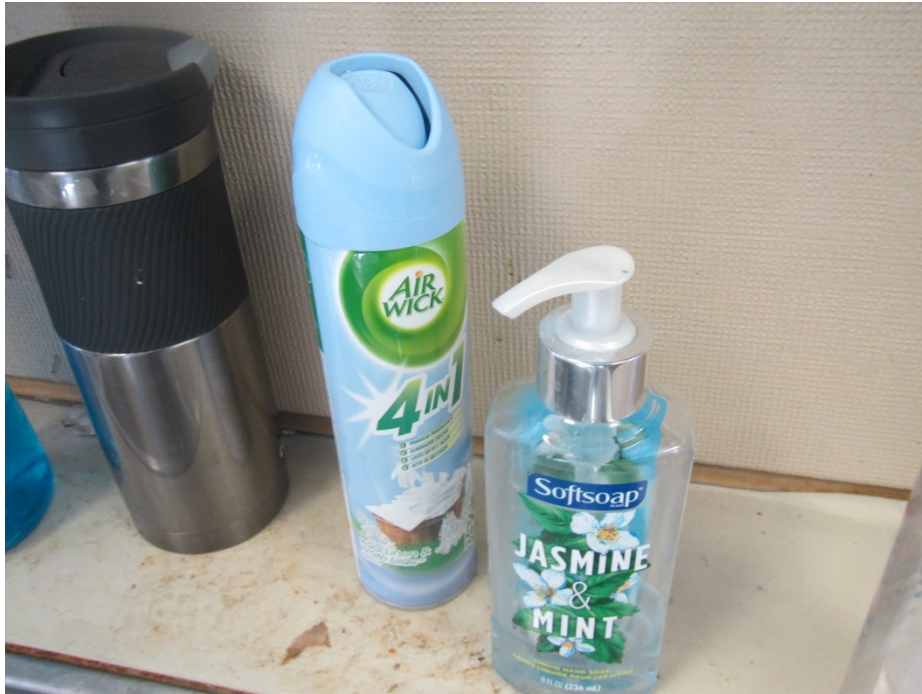
**Picture 13**

**Air freshener and scented hand soap**

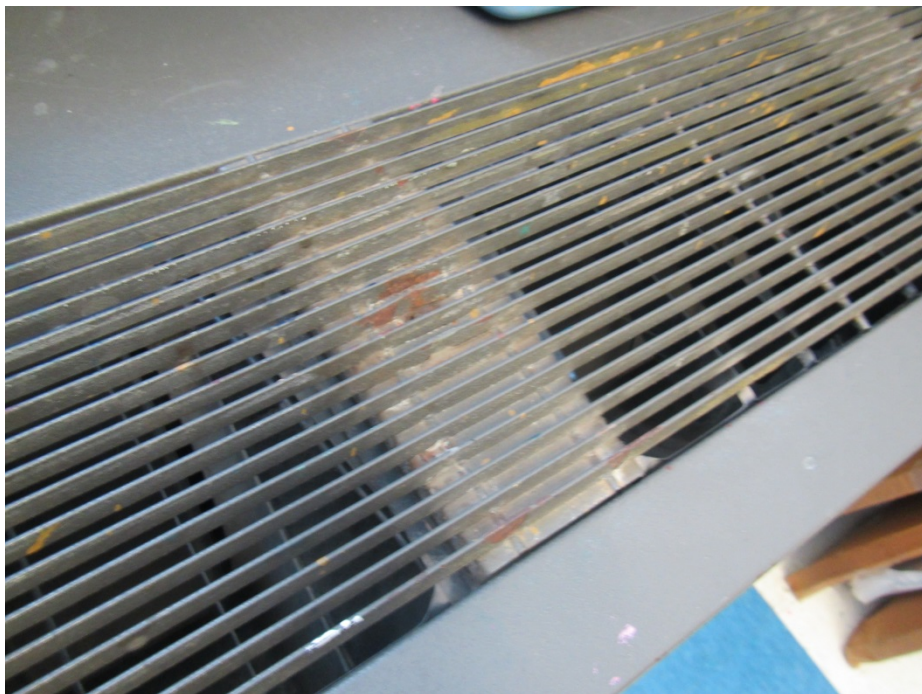
**Picture 14**

**Debris in univent grill**

25. Ensure copy machines, laminators and other appliances are used in areas with adequate ventilation and away from occupants.
26. Continue to change filters in HVAC units at least twice a year with MERV 8 or higher filters. Clean HVAC and univent cabinets of debris and dust when filters are changed.

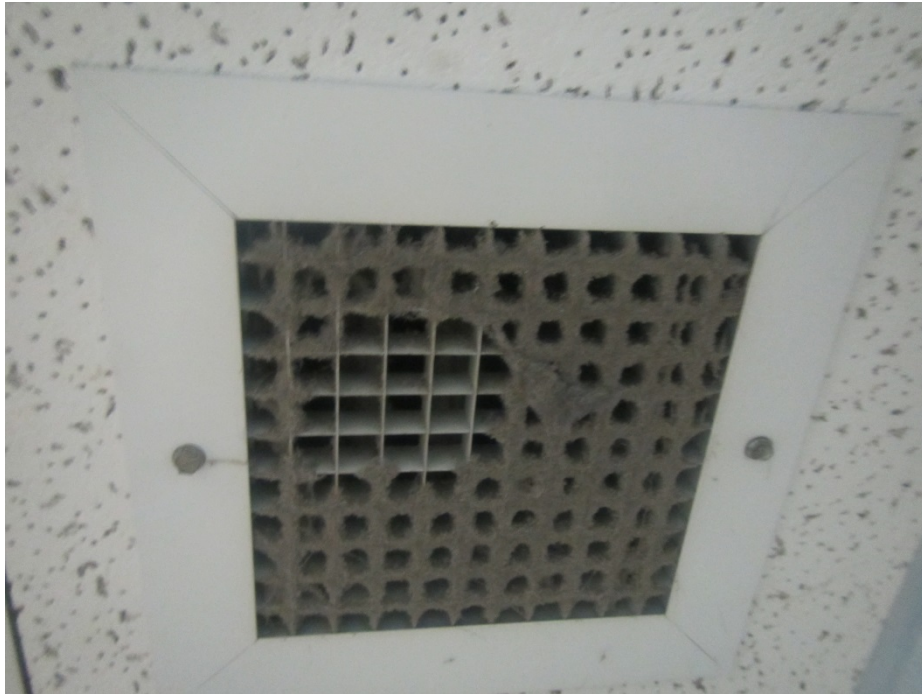
**Picture 15**

In many areas, supply vents, exhaust vents and personal fans were dusty (Pictures 15 and 16; Table 1). This dust can be reaerosolized under certain conditions, and can also be a medium for mold growth.

**Heavy dust accumulation on exhaust vent**

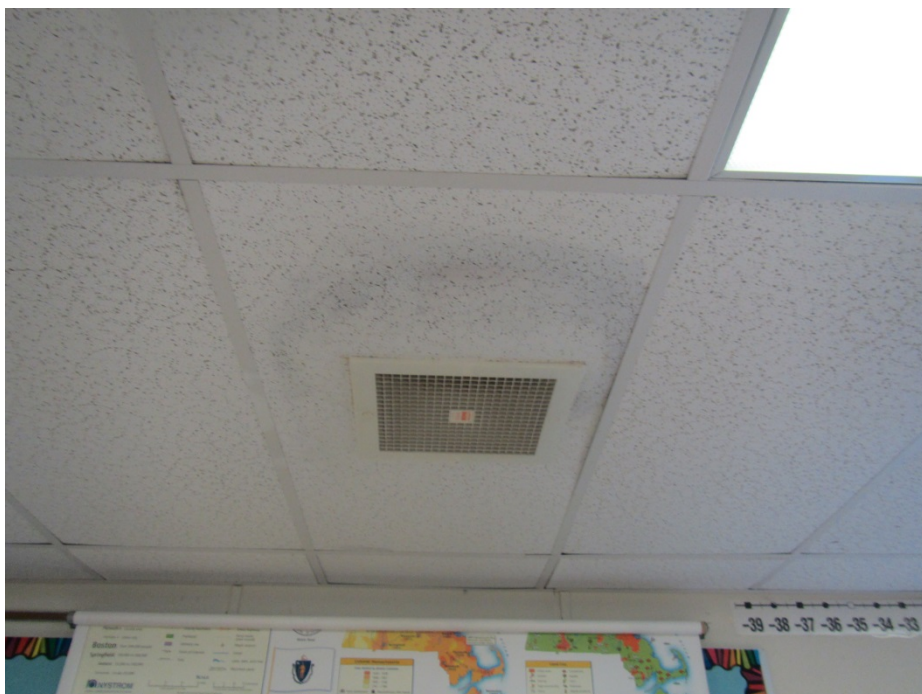
**Picture 16**

**Dusty vent and ceiling tiles in a modular classroom**

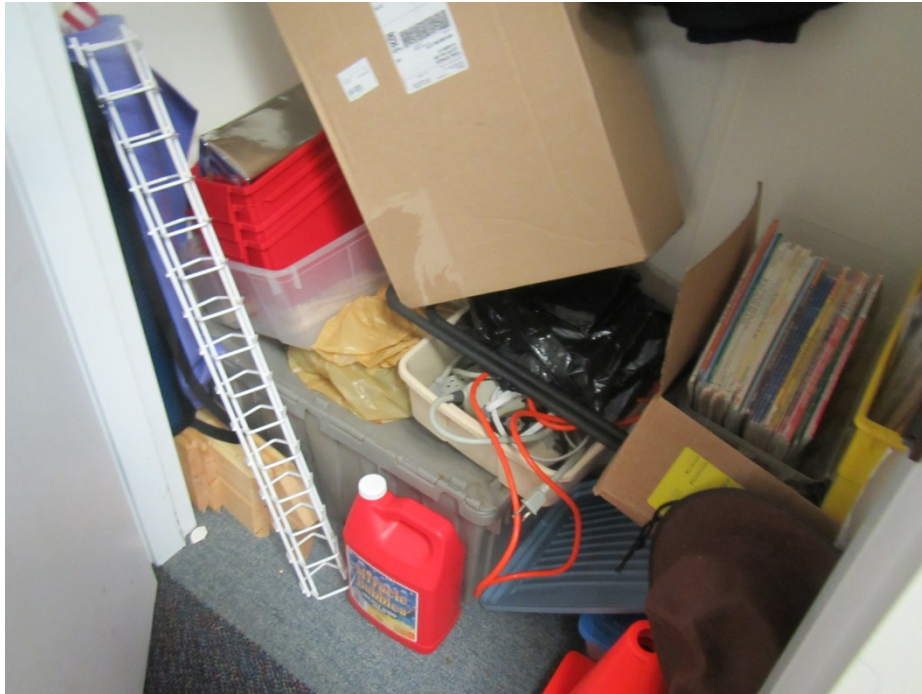
**Picture 17**

In many classrooms and particularly in storage areas, large numbers of items were on floors, windowsills, tabletops, counters, bookcases and desks, which provide a source for dusts to accumulate (Picture 17). These items (e.g., papers, folders, boxes) make it difficult for custodial

**Items in a storage closet**

30. Relocate or consider reducing the amount of materials stored in classrooms to allow for more thorough cleaning of classrooms. Plan regular clean-outs to remove and organize items in storerooms, particularly science storage areas. Clean items regularly with a wet cloth or sponge to prevent excessive dust build-up.
